*“Published as a ‘Case Study’ in the
‘Journal of Aerospace Sciences and Technologies’
[Aeronautical Society of India]
May 2011 issue (Volume 63, Number 2)-ISSN 0972-950x”*

CASES OF FALL OF BLUE AIRCRAFT ICE FROM SKY IN INDIA

Bimal K. Srivastava,
Former General Manager (Airports Authority of India)
G-11, Second Floor, Green Park Extension,
New Delhi-110016

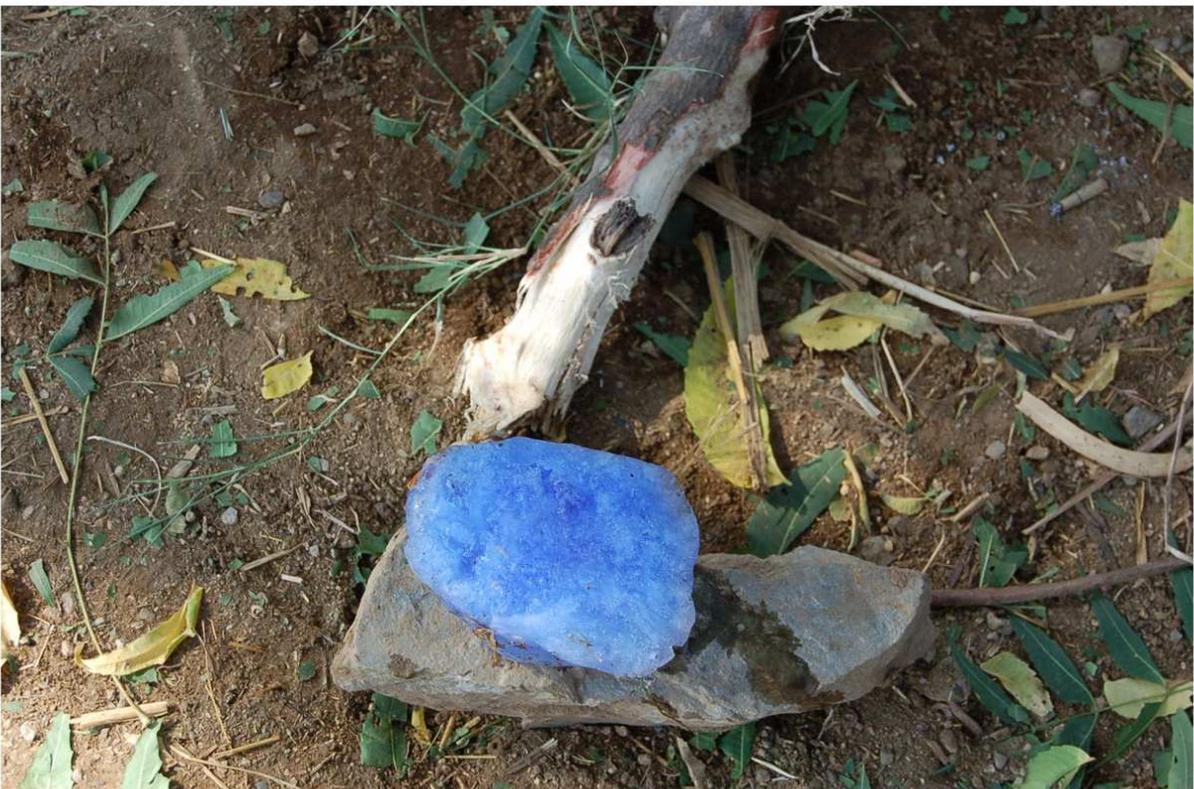
This Piece of Blue Ice is most likely from the aircraft flying over the International Air Route A791W Kolkata-Karachi on 06th Oct. 2009 found near Mt. Abu (Rajasthan). Photo Courtesy-Proff K.K. Sharma

And then there was another notable Incident of fall of Blue Ice that had occurred near Mt. Abu (Distt Sirohi, Rajashthan) on 06th Oct 2009, when a large lump of blue Ice weighing about 25 Kgs fell from the sky in a farmhouse in Tokra village near Mount Abu (Approximate Geographical Coordinates 24⁰40'25" N, 72⁰42'40" E) at around 0515 Hrs IST. There were no rains and sky was clear with Temperature touching around 38⁰ C. The ice had melted down to about 4-Kgs and turned into a liquid deep blue in colour and sticky.

The case was examined by Dr. (Prof) K. K. Sharma, Head of the Deptt of Geology at the Government College, Sirohi, alongwith the team of Professors Dr. Ritesh Purohit (Lecturer, Geology) and Dr. Sanjay Purohit (Lecturer, Bio Technology). The team also consulted Jesus Martinez-Frias, a planetary geologist at the Center for Astrobiology in Madrid, and a pioneer researcher of large sized Ice lumps (Known as Megacryometeors). And then the case was declared as the ice from the lavatories of an aircraft. It may be mentioned that the an International ATS Route "A-791W (Westbound)" from Kolkata to Karachi passes through that area. It is possible that an airliner cruising at an high altitude over the route might have dropped the ice lump due to heavy weight of the same.
